46906 Fernald Common
Fremont CA 94539

8/21/2017

PACIFIC WEST PROPERTY INSPECTIONS, INC. dba HOUSEMASTER

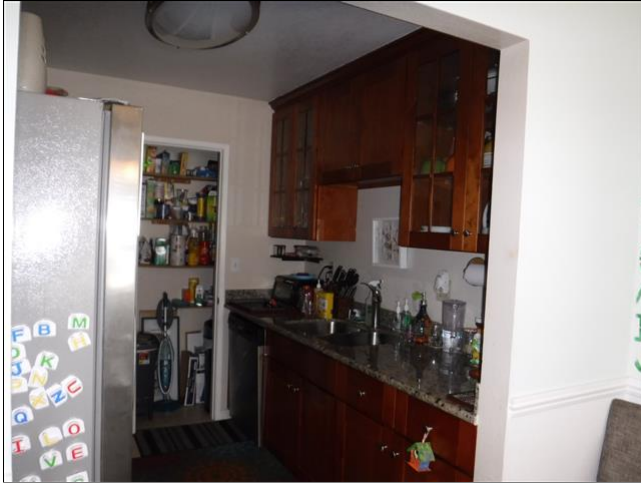
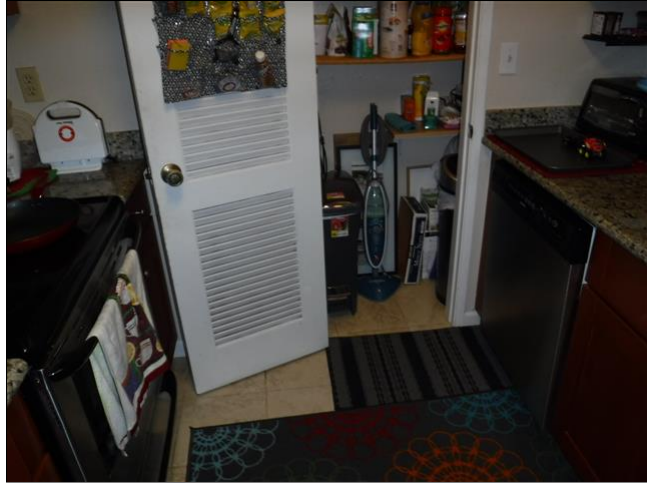
●				4.0 WALLS / CEILING
	●			4.1 ELECTRIC / GFCI No GFCI outlet in the kitchen near the sink. Recommend adding GFCI outlet to the plugs near the sink and the entire countertop.
●				4.2 OVEN
●				4.3 RANGE
●				4.4 DISHWASHER
●				4.5 DISPOSAL
●				4.6 SINK Some rust below the sink at the connection of the sink and the disposal.
●				4.7 VENTILATOR
●				4.8 CABINETRY
●				4.9 COUNTERTOP

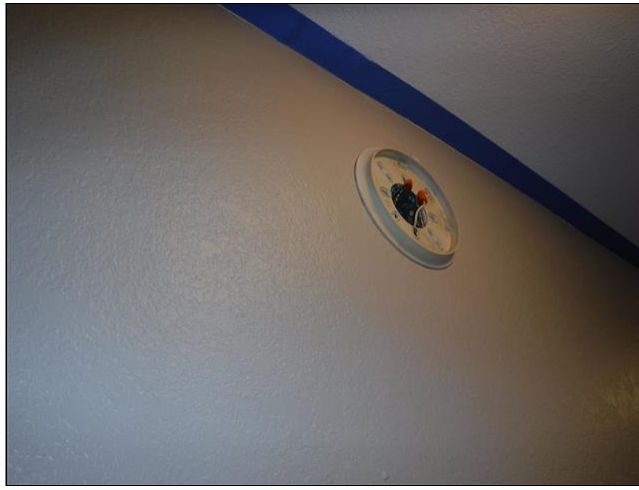
5.6 SMOKE and CARBON MONOXIDE DETECTORS Item 1(Picture)

●					5.0 CEILINGS
●					5.1 WALLS
●					5.2 FLOORS (FRAMED)
●					5.3 INTERIOR ROOM DOORS
●					5.4 SLIDER/PATIO DOORS
●					5.5 ELECTRIC / DEVICES Any loose, broken, or missing outlet covers or plugs will need to be replaced/repaired.
	●				5.6 SMOKE and CARBON MONOXIDE DETECTORS No CO detector in the condo and the smoke detector in the hallway has been removed. Recommend having a new smoke and CO detector installed.
●					5.7 FIREPLACE(s)
